Roots of Mold Problems and Humidity Control Measures in Institutional Buildings with Pre-Existing Mold Condition

Texas A&M University, College Station, Texas

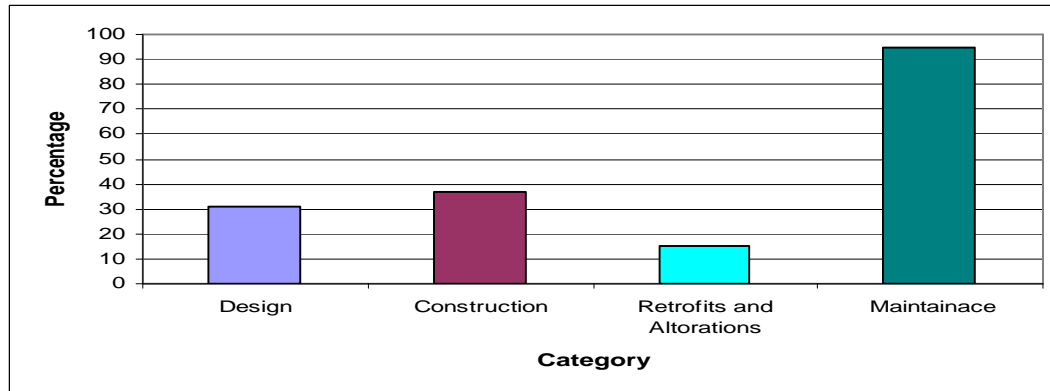
The first of these categories, the one in which an engineer has the most control over, is HVAC design. A building should be designed properly to provide a comfortable environment so that its occupants will be able to conduct their duties. The building should be provided with the proper type and kind of equipment for it to be properly cooled or heated. It is also crucial for a building to have a positive differential pressure to the outside atmosphere. If the building is negative, the engineer will have no control as to what type of air will be drawn into the building making it impossible to control the humidity level. Figure 1 shows that 31 percent of TAMU buildings with humidity problem were categorized as having a design problem.

Figure 1: Percentage Category breakdown for Texas A&M University Buildings with Humidity Problem

Once a building has been in place for several years changes have to be made to it in order to better fulfill its purpose, for example, a conference room has to be changed into four new offices or a classroom has to be converted into a computer or server room. There are also advancements in the technology utilized in the office environment. Offices must now have fast and reliable Ethernet connections. There is also the need for additional telephone lines for fax machines and other office equipment. All this wiring has to be directed and distributed throughout the building. In order for this to be done, electrical conduit has to be run through walls and from floor to floor. Often the breaks made in walls and ceilings are not properly sealed. It is really not an aesthetic problem since most of these holes are made above false ceilings and hidden from public view, however these holes combined with pressure differential are enough to allow for undesired flow through the building. For the TAMU buildings with humidity problems, 15 % were categorized as having been caused by retrofits and alterations (figure 1).
